# Quick Service

## HEADSAIL HANDLING

## Jib Reefing & Furling Systems

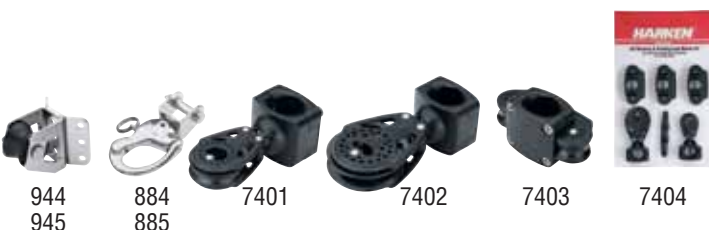
## FURLING LEAD BLOCK KITS

Harken recommends equipping every system with Carbo lead blocks for safe furling from the cockpit. The 7404 lead block kit provides a complete system for most boats. Fits 1" (25 mm) stanchions.

7402 Ratchet: Maintains tension when spooling for smooth furling.

7403 Outboard assembly: Keeps furling line outboard of stanchion.

7401 40 mm block: Inboard lead on the bow pulpit.

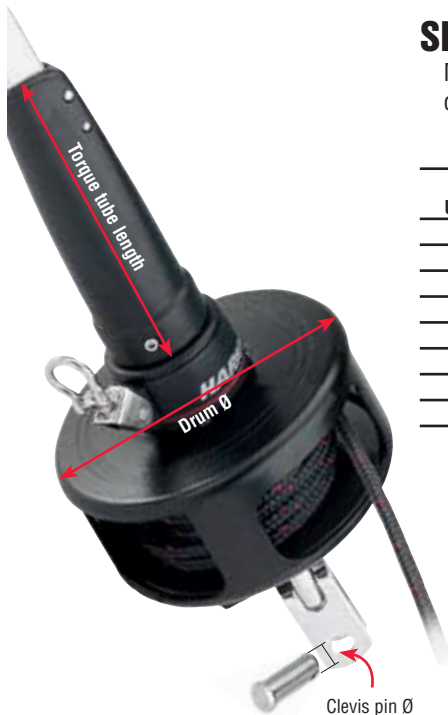
### SIZE IDENTIFICATION (MKI, MKII, MKIII)

MKIV and Cruising furlers have unit size printed on label. For older models use drum diameter (measure across top of drum), clevis pin diameter, and torque tube length.
